Investigations of Delamination Fault in Photovoltaic Panel Using Thermographic Image Analysis

N.Sathya¹, C.Muniraj²

PG Student, Department of EEE, K.S.Rangasamy College of Technology, Tiruchengode, Namakkal, Tamilnadu, India¹

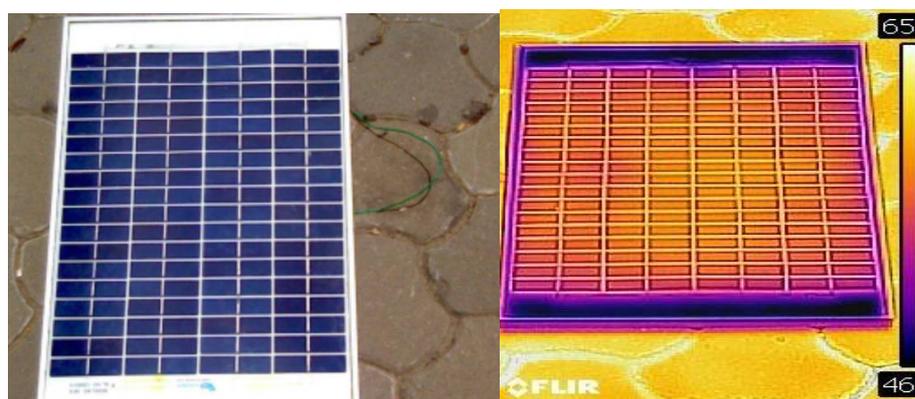
Figure 3. Delamination fault PV 1 panel

In a PV module, the EVA (ethylene vinyl acetate) protects the sensitive cells from weather influences such as moisture, UV radiation and mist. During manufacturing process it is important to laminate the module composite under a precisely defined pressure and temperature and time to ensure that the EVA cures correctly. Due to wrong process parameters or cheap material it can result in a delamination of the EVA later in lifetime. The layers of EVA melted and get a "milky" color. These delaminated solar modules should also be changed. Due to the delamination, moisture can get to the cells which results in cell corrosion. Further, the light transmission is reduced which results the ongoing performance loss. Figure 3 and 4 shows delaminated PV1 and PV 2 module with its thermal image which is captured by the FLIR thermal imager. In the normal image of delaminated PV panel 1 and 2 the milky white can be seen, which is spread all over the panel. And in the thermal image the color/tonal distribution of the panel is seen clearly and it is not equally distributed throughout the panel. The color intensity distribution is based on the temperature. The temperature of the panel PV 1 ranges from 46 to 65°C and in PV 2 ranges from 47 to 71.3°C. It can be noticed that in thermal image the certain cell regions are brighter (higher intensity of color in the cells) due to the higher temperature which indicates the defective cells.

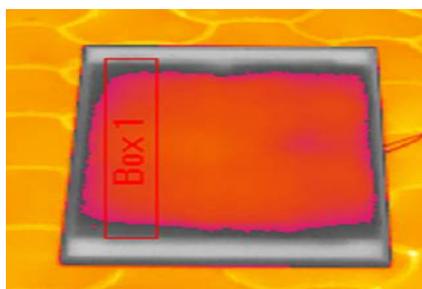
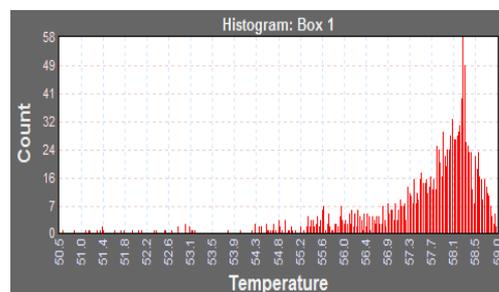
Figure 5. Thermal image of Delaminated panel with its histogram

According to the semi-empirical equation as mentioned in section 2 the operation temperature of a healthy cell $T_{cell}=56.74^{\circ}C$. In this paper, a histogram analysis was applied to box ROIs within the obtained thermal images of PV-1 and PV-2. Focusing on PV-1 module, a vertical box were selected as box ROI. According to the ROI analysis, cells with hot spot is covered in the ROI. Fig 5 present the thermal image and its histograms of ROI, respectively, for the measurement of 1 October at 13:00, with regard of PV-1. In histogram for box1 there is a pixel (Y-axis) distribution in the temperature (X-axis) range from 59 to 62°C. In this there is high dispersed data in the center (172.0, 96.5) 58.8°C which represents the delaminated cells and it should be noticed that there is rise in temperature in delaminated region as compared with operating temperature. The mean and the standard deviation of the box1 is 57.8°C and 1.2 as by above mentioned equation 2 and 3.

Range: 50.8 to 59.2°C - Pixel count: 1456

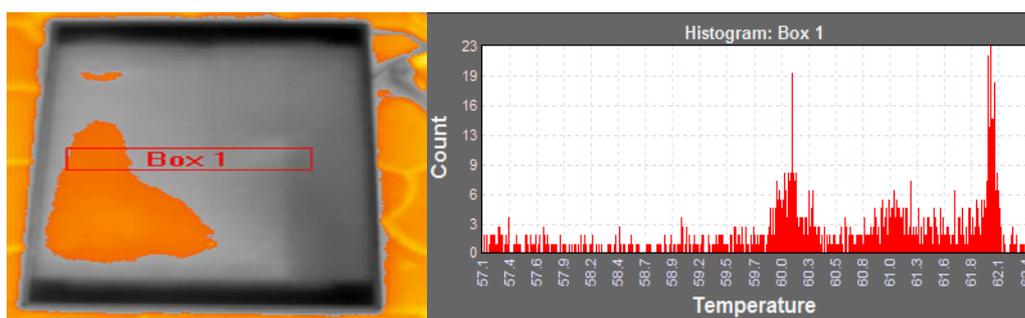
Figure 6. Thermal image of PV2 with its histogram

Similarly results were concluded from the histogram analysis of PV2 thermal image. In the thermal image of PV2 the regions were clearly seen and for the ROI analysis a horizontal box were selected as box ROI, it covers from left to right of the cells. The cells with hot spot and the healthy cells were covered in the box ROI. Fig 6 presents the thermal image and its histograms of ROI, respectively, for the measurement of 1 October at 13:00, with regard of PV-2. In histogram for box there is a pixel (Y-axis) distribution in the temperature (X-axis) range from 57 to 62°C. In this there is high dispersed data in the region (116, 103) 62°C which represents the defective cells and there is maximum temperature in that region as compared with operating temperature. And there is less dispersed data in the region 57 to

60°C and since it represents the healthy cells, these cells temperature are equal to the operating cell temperature. The mean and the standard deviation of the box1 is 60.6°C and 1.3.

Range: 57.1 to 62.4°C – Pixel count: 1526
