A Novel Methodology to Debug Leakage Power Issues in Silicon- A Mobile SoC Ramp Production Case Study

The devices used for mobile applications have stringent power requirements. The devices thus have power conservation modes during which the current drawn is extremely low of the order of tens of microamperes. This paper discusses the challenges and techniques used to identify the issues found in shutdown mode (a power conservation mode), which had to be addressed in order to ramp the device to production.

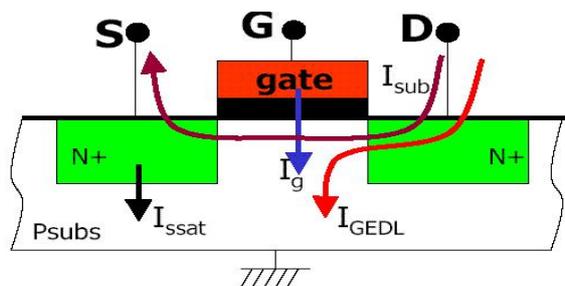
Figure 1 explains the various leakage components in a CMOS device

Figure 1: Different leakage in CMOS device

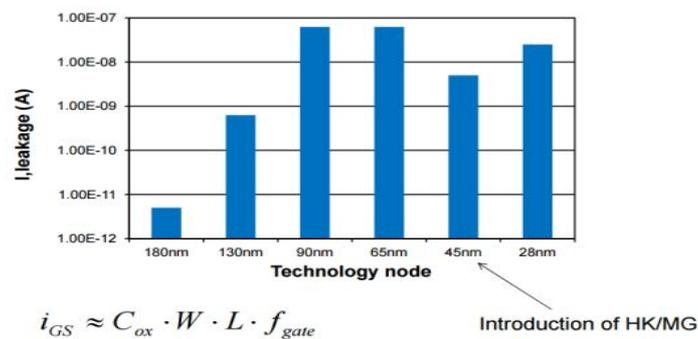
As the technology shrinks operating voltage decreases but the threshold voltage does not decrease proportionally, which leads to large leakage in deep submicron (DSM) designs. Starting 90nm & moving towards 14nm technologies, leakage is a major component of the total power. Figure 1a indicates the typical leakage numbers for various technology node. The

Figure 2: A typical leakage numbers in various technology nodes

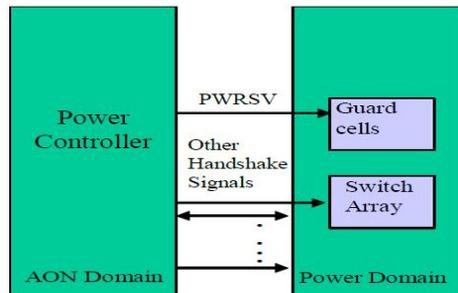
The leakage power saving strategy requires special cells, namely switches and guard cells to be part of the standard cell library. The switch cells are used to cut-off power to the logic gates in shutdown mode. The guard cells need to be placed on signals that cross power domains, to ensure that all inputs of powered domain are driven. In the absence of guard cells, the inputs of cells, in powered domain driven by the output of powered-off cell, will be floating. The guard cells essentially act as tie off cell in power saving mode and as buffers in the normal functional mode. The guard cells thus are buffers with an additional control signal, called PWRSV. The commonly used guard cells are TIE0 that ties a node to low (when PWRSV is high) and TIE1 that ties a node to high (when PWRSV is high). Figure 2 summarizes the power conservation architecture.

Figure 3: Interfacing of different power domains

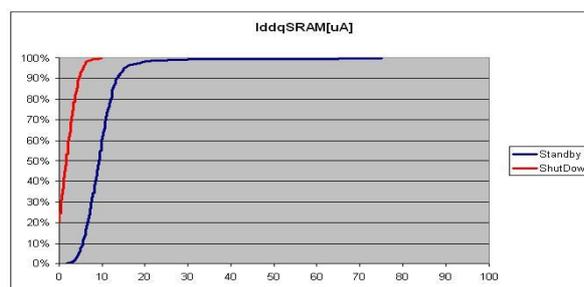
Figure 4: Plot of VDDram IDDQ

Figure 4 shows the IDDQ current variation, in RAMs, in standby mode and shutdown mode. Note that the standby mode current curve and shutdown mode current curve don't intersect. The distance between two curves indicates power saved.

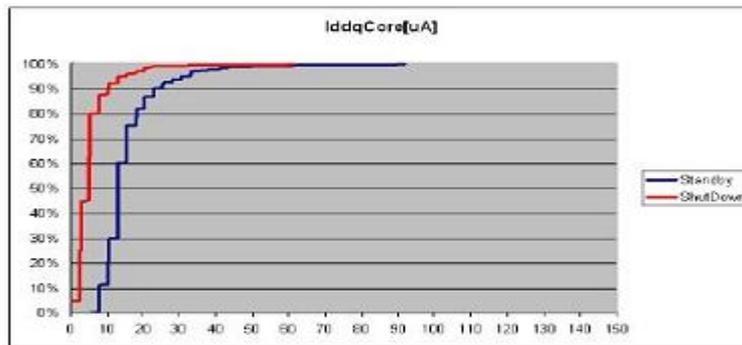
Figure 5: Plot of VDDcore IDDQ

Figure 5 shows the logic power domain IDDQ variation in standby mode and shutdown mode. Note that the tails of shutdown IDDQ curve intersects the standby IDDQ curve. The plots indicate that shutdown mode current for RAM power domain was close to estimation while those for logic power domain were way off. The analysis of the two plots concludes that the VDDcore domain only has high IDDQ issue. The plots also helped us rule out problem in switch cell because the same switch cells are used in RAM and logic power domain. Thus the problem statement was reduced to finding floating nodes within VDDcore power domain.

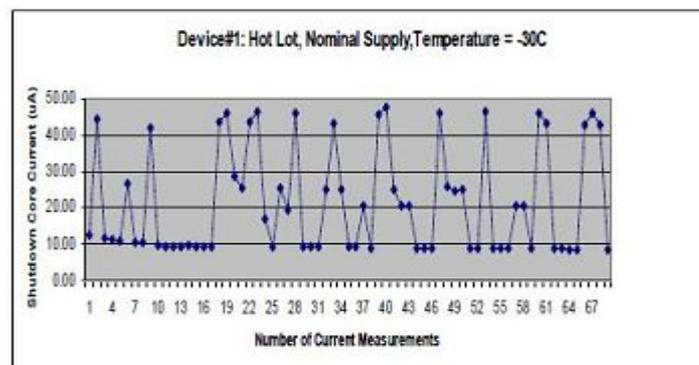
The detailed study of bench set-up indicated that the device was not coming out of a wait state. This resulted in the device always being in a known state on every power cycle, resulting in no current variation. The device required a particular transaction on the peripheral interface to come out of the wait state. On further bench experiments with the desired transaction the shutdown IDDQ current was measured. Figure 5 depicts the result of current measurement with power cycling on a single device with required transaction on the peripheral.

Figure 6: Shutdown IDDQ variation with power cycling

The above figure proves our hypothesis of floating nodes being the cause of high IDDQ variation in shutdown mode.

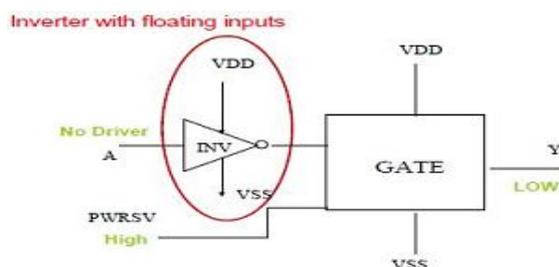
Switches were ruled out because RAM current was matching the expected results and logic Power domains also used similar switches. Always ON logic cells and always-ON buffers were also ruled out since they would have caused IDDQ issue in other power modes as well. The root-cause thus was narrowed down to guard cells. A detailed review of TIE0 guard cell circuit design revealed a discrepancy in the TIE0 Cell usage. TIE0 cell have to be placed in powered off domain. In our design 79 cell instances were placed in AON domain.

Figure 7:TIE0 guard cell transistor schematic

Figure 7 clearly shows a high IDDQ scenario in TIE0 cell when “A” input is floating and VDD power supply is present. In the actual design, the input “A” is floating during shutdown mode because it will be driven by a powered off logic. To fix this in silicon, conventional FIB (Focused Ion Beam) approach was first looked at. In DSM technology it is very difficult to FIB lower metal layers which ruled out fixing all the 79 cell instances after careful analysis of layout and design a reduced list of 12 FIB points was identified. The FIB effort was estimated as 40 hours for this reduced list. The FIB expenses are around \$300/hr. The FIB option was ruled out since the cost of \$12K per device was not justified given the low probability of FIB success even for a reduced fix. Hence there was a need to identify alternate methods and technology to fix this issue conclusively.

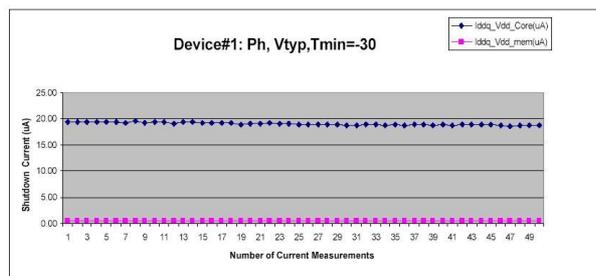
Further bench results with and without transaction were correlated to different voltage levels at “A” input of TIE0 cells prior to shutdown mode entry. A detail analysis of software sequencing of the device with and without the transaction on peripheral revealed that 16 out of 79 TIE0 cells could have random values after power-up. The values on the inputs of 16 TIE0 inputs could also be controlled through special software patch. The Shutdown currents were measured with different known values forced on the 16-TIE0 input nodes through software patch. Figure 7 shows the IDDQ current values in shutdown mode with value of 0x0000 on these 16 TIE0 cells prior to shutdown mode entry.

Figure 8:Shutdown IDDQ variations in power cycling with patch download for value 0x0000

As shown the multiple current readings are now constant which provides that TIE0 cells in AON domain caused the IDDQ problem.

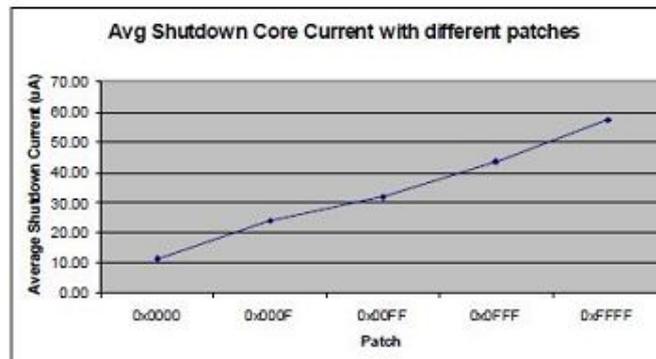
Figure 9:Shutdown IDDQ variation in power cycling with different patch download

Figure 9 shows IDDQ current variation with different values on the 16 TIE0 cells. Figure 8 shows a linear increase in IDDQ current with increase in number of TIE0 cells having “A” input as high before shutdown mode entry. This confirms the hypothesis of TIE0 to be one of the root causes of the problem. We still had to rule-out the presence of other floating nodes. To rule out any other floating node other than TIE0 silicon debug technique, EMMI was used. EMMI technology [3] is used to identify the hot-spots in the design that could indicate presence of floating nodes in silicon. EMMI technique essentially works on the principle of sensing heat emission to identify hot spots on silicon. The logic that has floating nodes will draw high current, resulting in excess power dissipation subsequently resulting in temperature increase in that region. The EMMI images thus indicate hot spots as red or yellow dots in the image. The EMMI requires currents to be in hundreds of microampere to reliably detect hot spots.

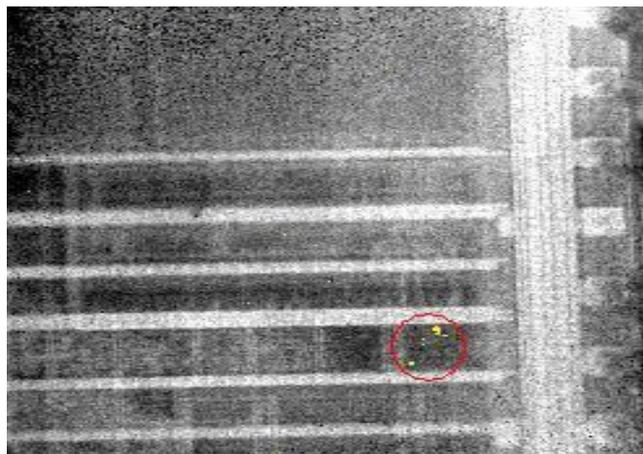
Figure 10:EMMI image at Vcore=1.3V

Figure 10 shows the EMMI images with nominal voltage applied. As seen the image does not give reliable results since the current is only about 140 uA. To get a reliable image the current had to be increased significantly. It was proposed to select devices from strong process corner and also increase the applied voltage to achieve higher IDDQ current.

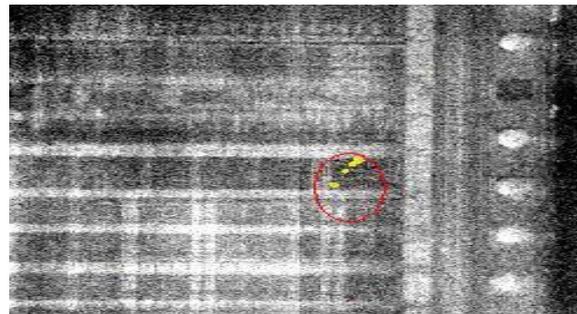
Unit-2 (999 uA@1.5V)

Figure 11:EMMI image showing hot Spot in the device at $V_{core}=1.5V$

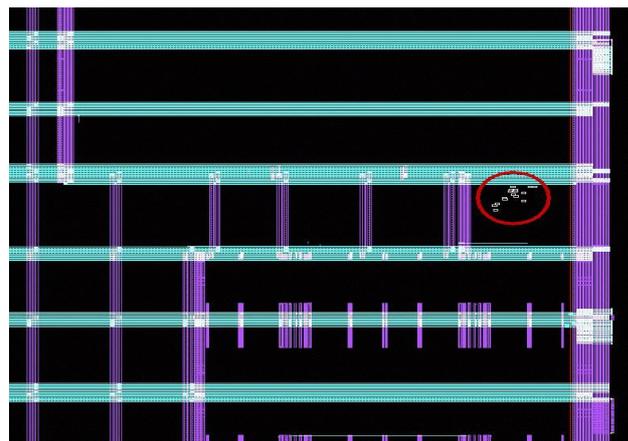
Figure 12:Layout image highlighting expected TIE0 floating nodes

Figure 12 shows the location of the same 16 TIE0 cells in layout, which were expected to be the culprits from patch, download experiment. By matching the hot spot (Figure 10) and the layout (Figure 11) it was confirmed that TIE0 was the only cause of high IDDQ current.
